# CLASSIC

### Inspection Report

**Property Address:**  
2009 Sample Drive  
Anytown PA 19422

<b>Date:</b> 4/30/2009	<b>Time:</b> 12:01:57 PM	<b>Report ID:</b> SAMPLE
<b>Property:</b> 2009 Sample Drive Anytown PA 19422	<b>Customer:</b> Mrs. Sample Report	<b>Real Estate Professional:</b> Harlan Glebe Classic Home Inspections

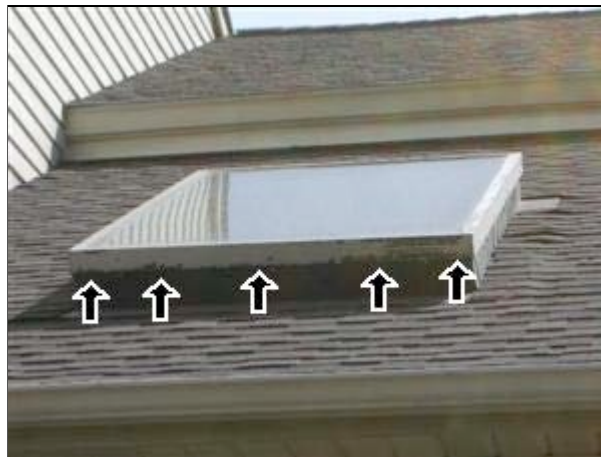
1.2 Picture 1

(1) FYI: Two Skylights at the at the Master bath and the Kitchen have peeling paint. Further deterioration may occur if not corrected. I recommend prep and paint repair as needed by a qualified contractor.

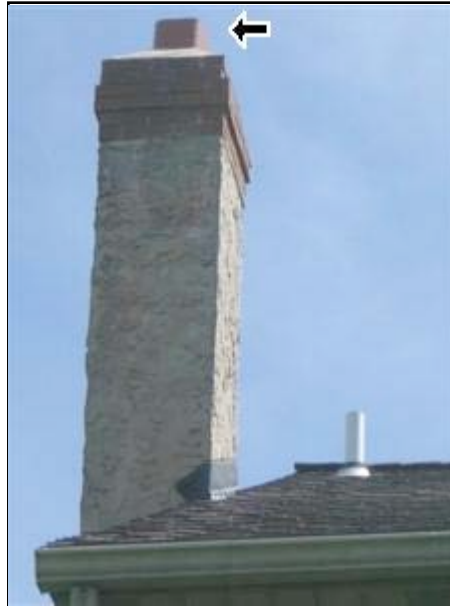
1.2 Picture 2

(2) The fireplace has never been used, for information purposes only. The chimney flue has no cap. I recommend having a cap and spark arrestor installed proactively. This will limit the

possibility of deterioration and will be required if the chimney is used in the future.

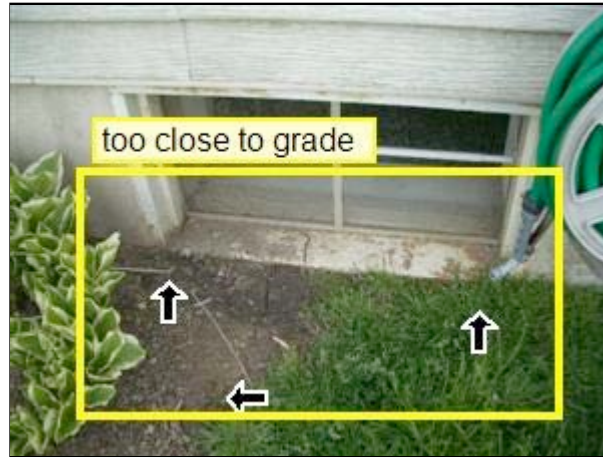
2.2 Picture 1

(1) Steel lintels above double hung windows on front of house have surface rust.

(2) Screen is missing from window above main front entrance. This exists and is stored in attic of detached garage.

(3) Steel window frames are rusting. This is partly from being close to ground level.

Recommend prep and paint maintenance by a qualified painter. This is a maintenance item for your information.

Recommend prep and paint maintenance by qualified person. For information purposes, basement windows would benefit from installing window wells with domed enclosures to keep weather off and heat in.

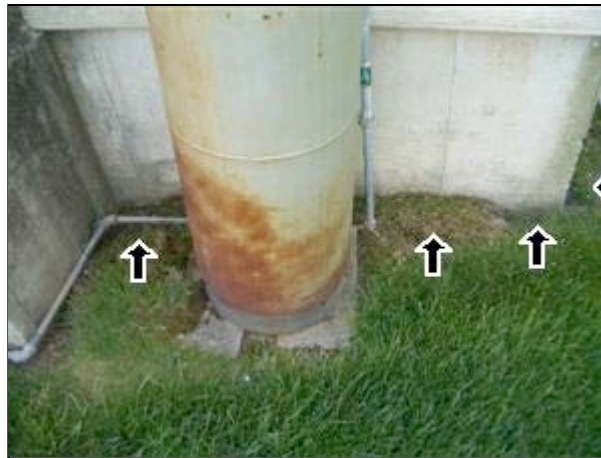
2.4 Picture 1

(1) There is a negative slope of grade toward house at the left corner (facing rear) of foundation. This can cause or contribute to water intrusion or deterioration. I recommend correcting landscape to drain water away from home.

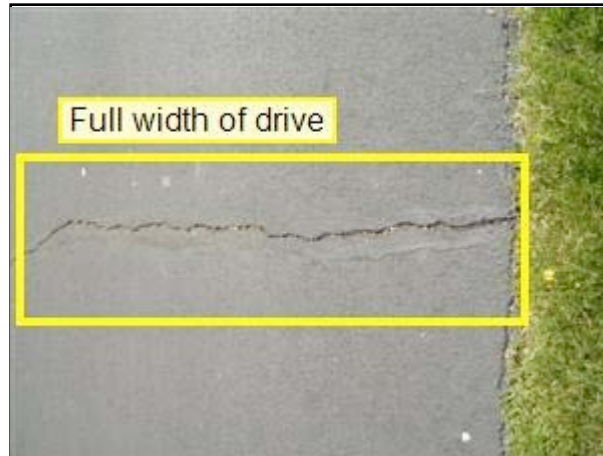
2.4 Picture 2

(2) Driveway has separation crack. This will allow water to penetrate and may get worse. Recommend filling crack with driveway asphalt filler up to flush with surface. Recommend

monitoring condition. This is for informational purposes only.

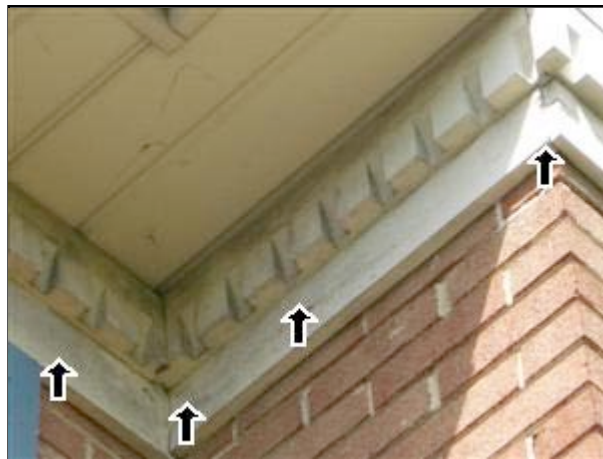
2.5 Picture 1

The wood dental fascia at eave across the front of home has peeling paint and has deteriorated. Further deterioration may occur if not repaired. A qualified contractor should inspect and do prep and paint maintenance as needed.

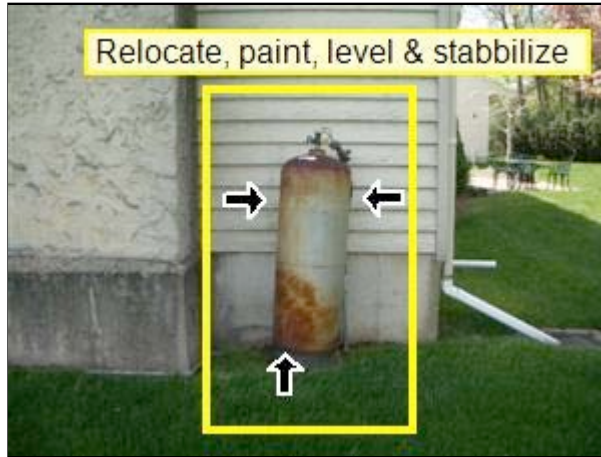
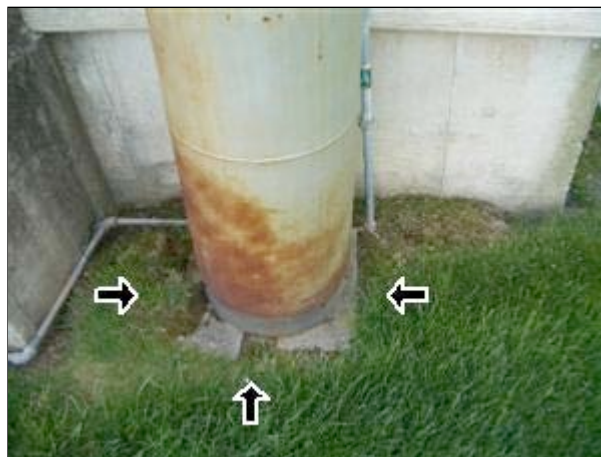
2.6 Picture 1

(1) Small Propane tank (used for the living room fireplace and shop heaters) is located at S.E. corner of house. This location is considered a potential safety hazard. Recommend relocating at least 10' from from building and any window, by a qualified plumbing contractor. FYI: Recommend that tank also needs prep and paint maintenance to minimize further deterioration and that a base pad be installed to keep tank level and stable .

(1) Small Propane tank (used for the living room fireplace and shop heaters) is located at S.E. corner of house. This location is considered a potential safety hazard. Recommend relocating at least 10' from from building and any window, by a qualified plumbing contractor. FYI: Recommend that tank also needs prep and paint maintenance to minimize further deterioration and that a base pad be installed to keep tank level and stable .

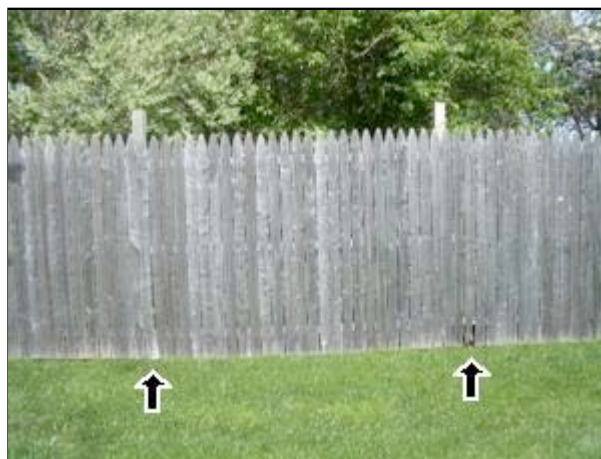
2.6 Picture 3

(2) Picket fence needs repairs by qualified person. Broken pickets, protective finish needed.

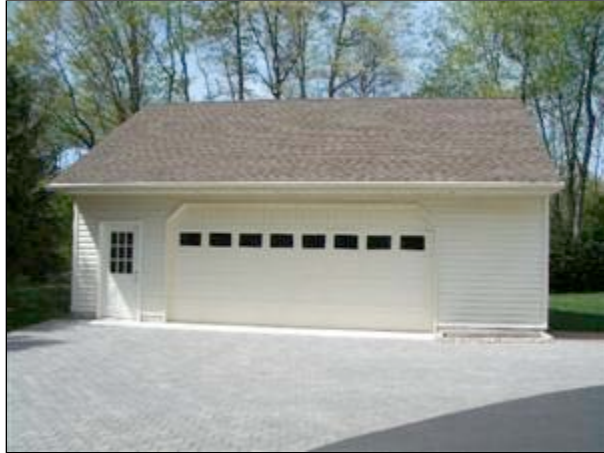
3.0.B Picture 1

North / front view of attached garage. FYI Approximately size 24' X 32'

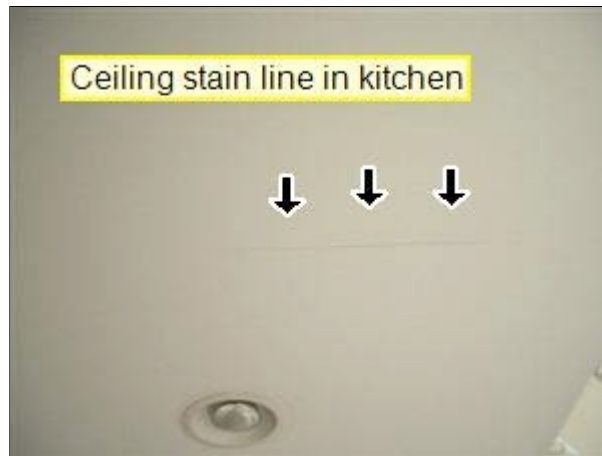
4.0 Picture 1

The drywall on the kitchen ceiling reveals a light stain which appears to be from an old water leak from the master bath sink trap above. The moisture meter was used and it did not indicate an active leak. I recommend prep, prime and paint as needed. Master bathroom above showed no signs of active leaking at time of inspection. Recommend monitoring.

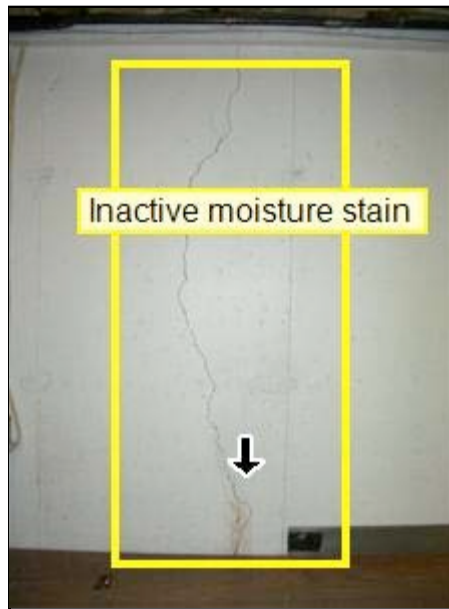
5.0 Picture 1

The small vertical crack in the foundation wall at the rear of home (South side of home) extends from sill to foundation. This shows inactive signs of water penetration staining. Owner commented that it has not been active in a number of years. Due to the fact that there is no negative grade toward the house, no repairs are foreseen at this time. This appears to be a typical settlement crack. I recommend monitoring during heavy rains which saturate the ground and raise the water table. This is my opinion and you may want a second opinion by a qualified building contractor.

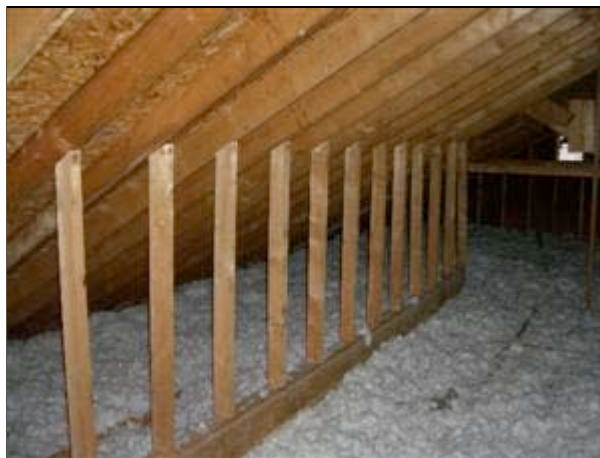
5.5 Picture 1

The attic access is located in 2nd floor hall closet by means of a pull down staircase. 2X6 roof rafters with collar ties and knee walls on both sides.

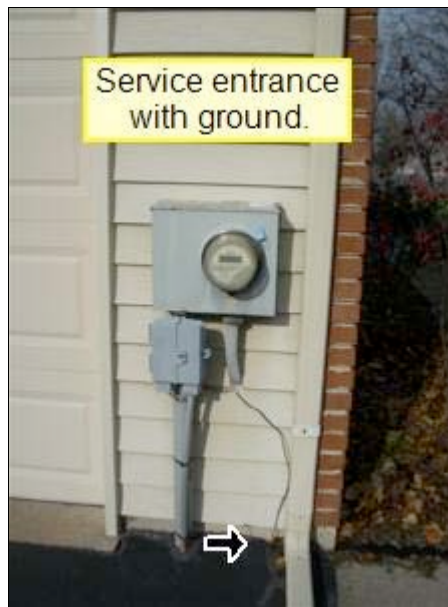
7.0 Picture 1

Main under ground service entrance. Ground rod not visible. ground goes to ground, but rod may be buried in asphalt.

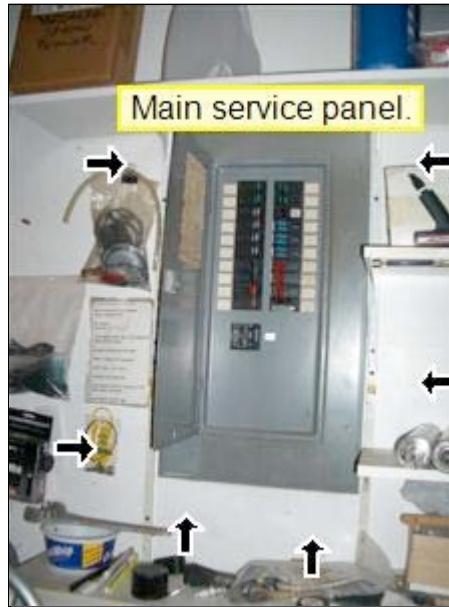
7.1 Picture 1

and unobstructed to floor was not maintained when shelves were installed. Recommend these be moved back to allow proper safety / service service clearance around panel.

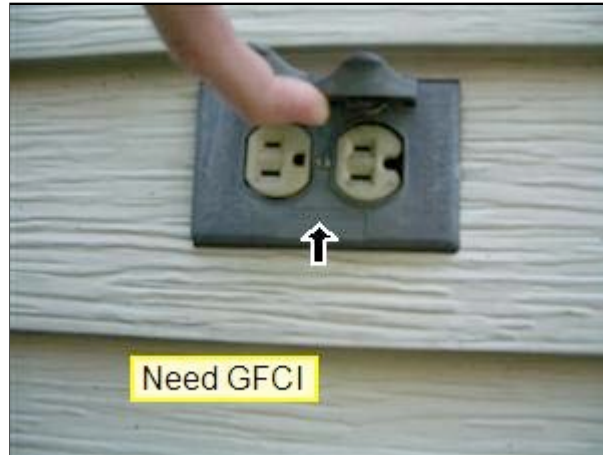
7.3 Picture 1

(1) Two exterior outlets in the front and rear of the house are not GFCI's. This is a potential safety hazard! Recommend replacing with proper GFCI protected outlets by a qualified electrician.

(1) Two exterior outlets in the front and rear of the house are not GFCI's. This is a potential safety hazard! Recommend replacing with proper GFCI protected outlets by a qualified electrician.
-

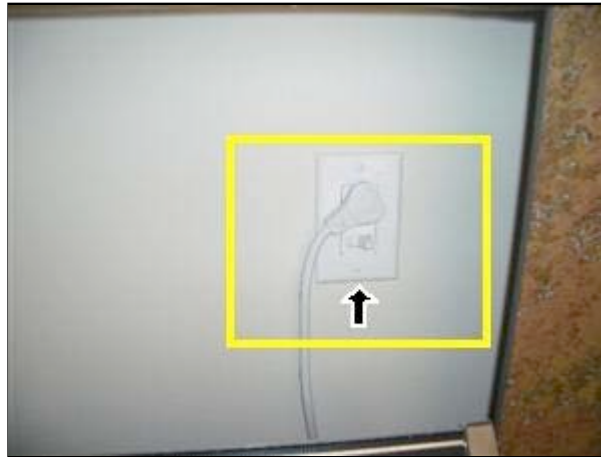
7.3 Picture 3

(3) The laundry receptacle is not a GFCI. This is a potential safety hazard! Recommend replacing with proper GFCI protected outlet by a qualified electrician.

(3) The laundry receptacle is not a GFCI. This is a potential safety hazard! Recommend replacing with proper GFCI protected outlet by a qualified electrician.

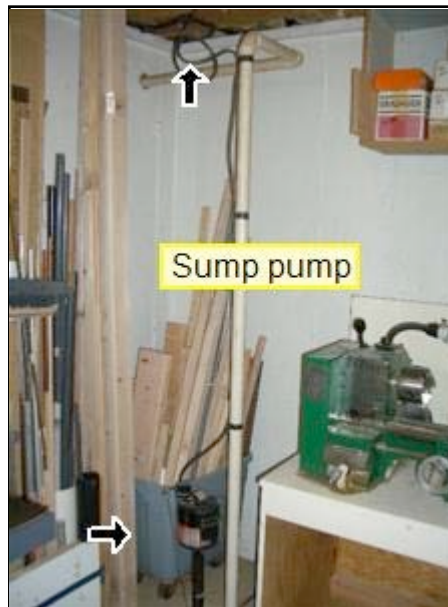
7.3 Picture 4

(4) The existing sump pump uses an extension cord and should have its own GFCI outlet, or a single dedicated receptacle. Electrical issues are considered a hazard until repaired. I recommend a qualified licensed electrician correct. The sump pump does not have a back flow valve, I recommend that one be installed by a qualified plumber.

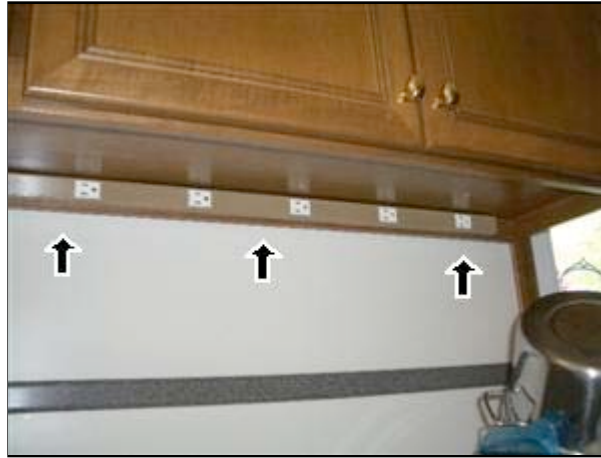
7.5 Picture 1

(2) FYI Note: Plug mold located under cabinets to the left of the kitchen sink are protected by a GFCI breaker in the main electric panel located in the attached garage. FYI: The plug mold next to the refrigerator is NOT GFCI protected because it is at least 6' away from the sink.

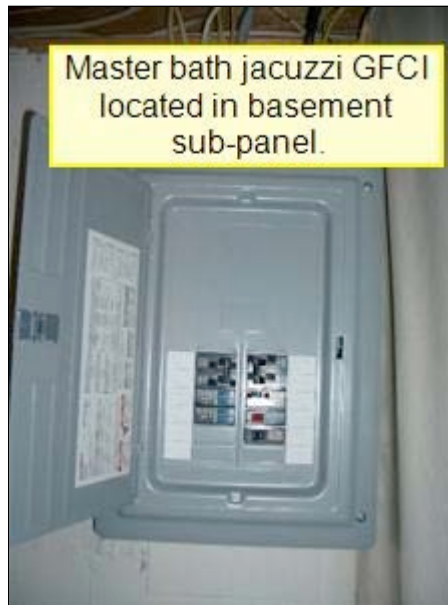
7.5 Picture 2

(3) FYI Note: Master bath Jacuzzi is protected by a GFCI breaker in the sub-electric panel located in the basement at the north wall.

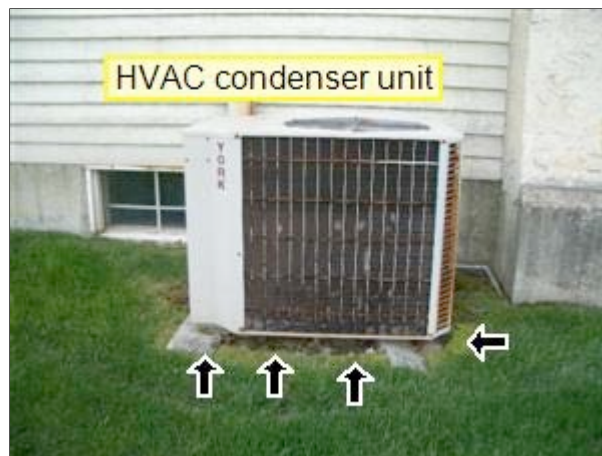
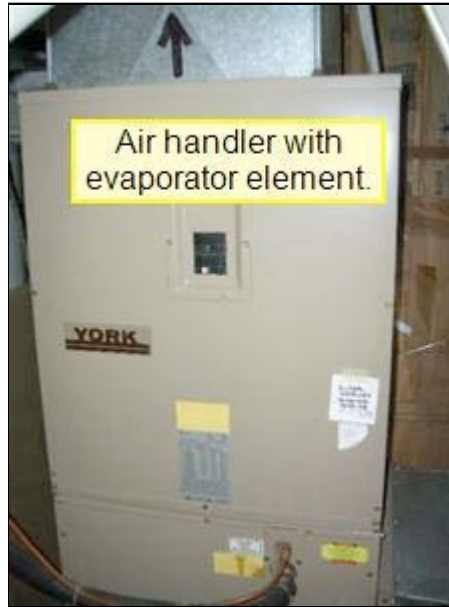
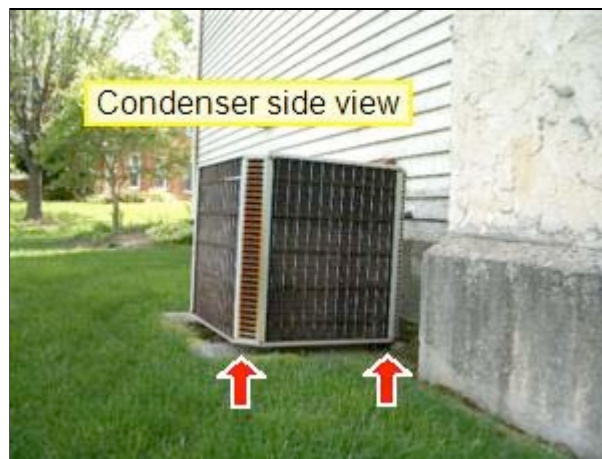
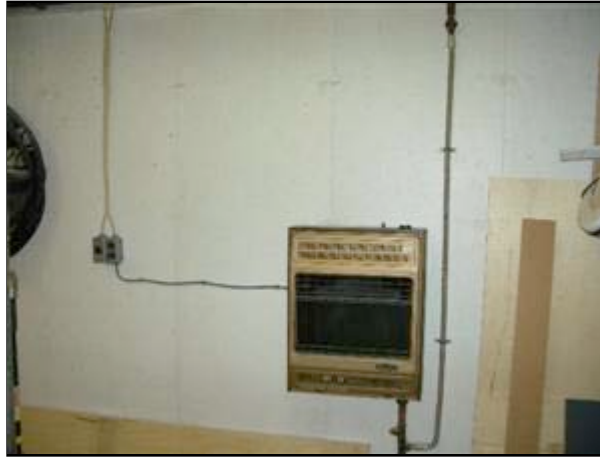
8.0 Picture 1

(1) The Air handler unit is 18 years old and does not respond to thermostatic controls. Evaporator was rusty but functional. One of (4) of the supplemental heating coils was not operative and may be required below 32 degrees. The platform for exterior Heat pump unit is not level, this is harmful to the compressor. The heat pump unit is also approximately 18 years old. Although operative, due to the age and condition, opinions on life expectancy will vary. I feel that the entire system is at or near the end of its useful life. I recommend an inspection and evaluation by a qualified HVAC contractor prior to settlement.

(1) The Air handler unit is 18 years old and does respond to thermostatic controls. Evaporator was rusty but functional. One of (4) of the supplemental heating coils was not operative and may be required below 32 degrees. The platform for exterior Heat pump unit is is not level, this is harmful to the compressor. The heat pump unit is also approximately 18 years old. Although operative, due to the age and condition, opinions on life expectancy will vary. I feel that the entire system is at or near the end of it's useful life. I recommend an inspection and evaluation by a qualified HVAC contractor prior to settlement.

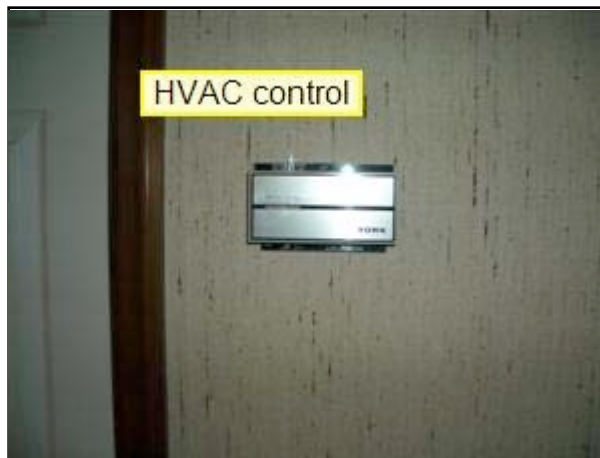
8.1 Picture 1

Controls are located in the family room. They are operating properly.

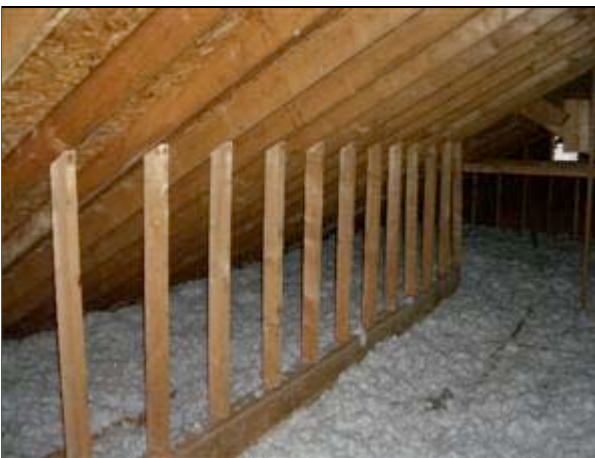
9.0 Picture 1

Blown in rock wool in attic. There is an obvious current or past presence of mice in the attic. I recommend an inspection by a pest control service to determine activity and possible access location as a preventative measure. I also recommend that a qualified contractor assess the insulation as to whether it has been disturbed enough to be effective at this time, and if it needs to be removed or replenished.

Blown in rock wool in attic. There is an obvious current or past presence of mice in the attic. I recommend an inspection by a pest control service to determine activity and possible access location as a preventative measure. I also recommend that a qualified contractor assess the insulation as to whether it has been disturbed enough to be effective at this time, and if it needs to be removed or replenished.

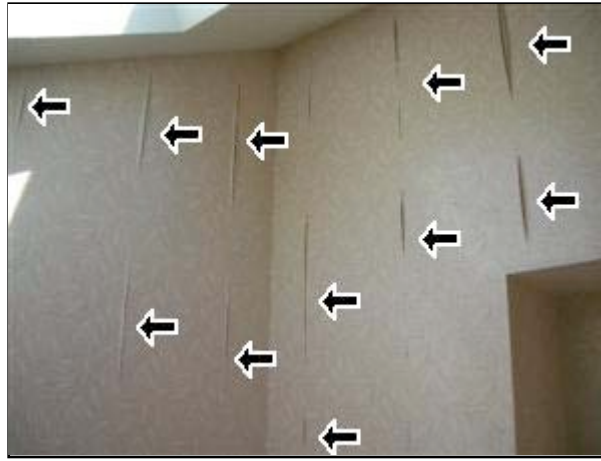
9.4 Picture 1

(2) Masterbath has a high vaulted ceiling. Wall paper is lifting badly, surfaces appear to be suffering from not enough ventilation. Recommend evaluation and repair by qualified building contractor.
